BERE REGIS
July 2002
BERE REGIS

CONSERVATION AREA APPRAISAL

BERE REGIS CONSERVATION AREA

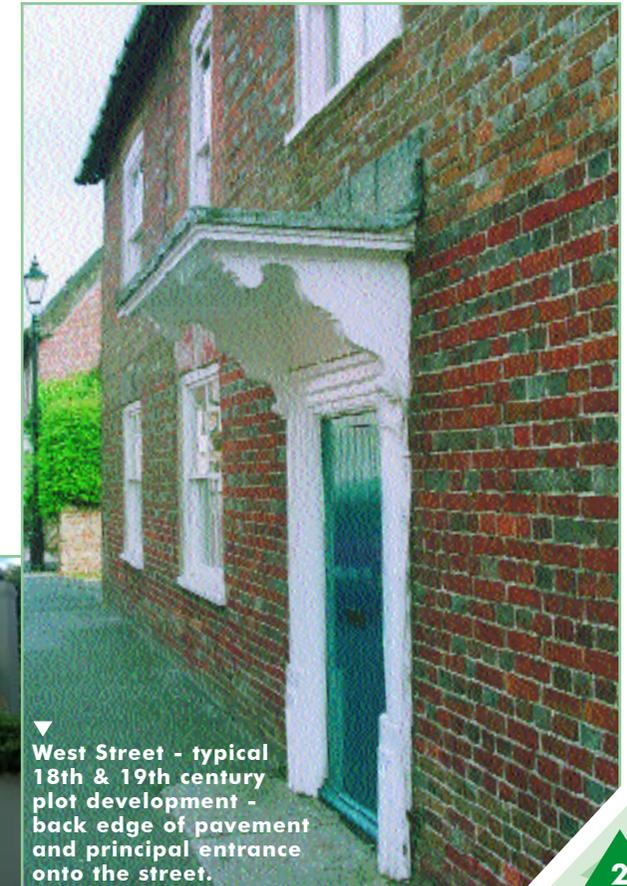
▼ West Street - typical 18th & 19th century plot development - back edge of pavement and principal entrance onto the street.

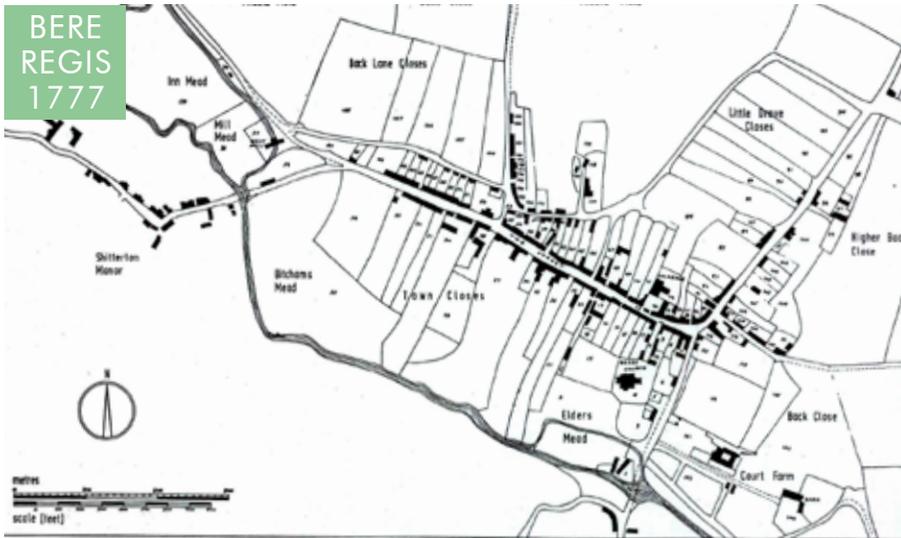
BERE
REGIS
1777

16 "THE TOWN OF BEERE REGIS" IN 1777

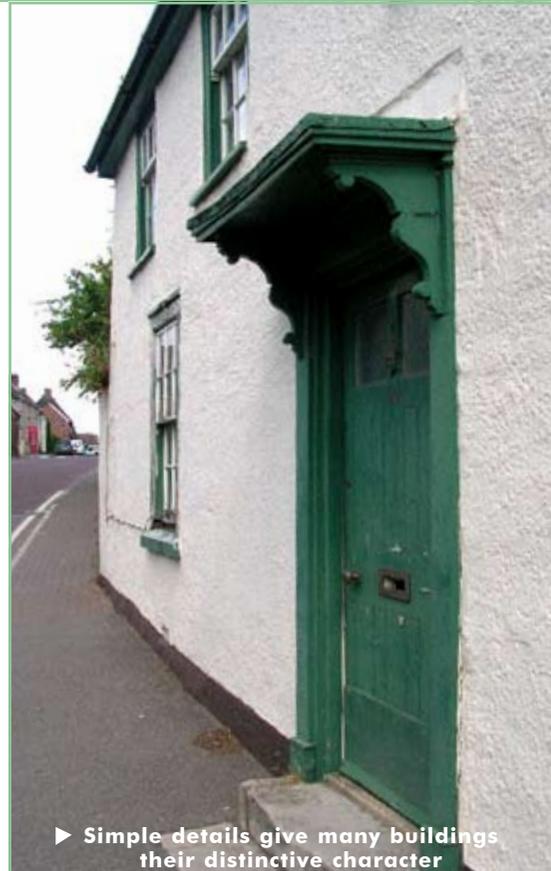
▶ Simple details give many buildings their distinctive character

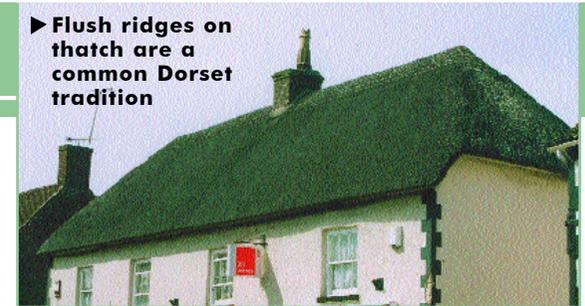
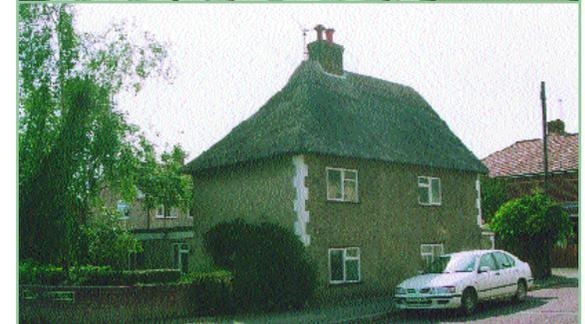
► Flush ridges on thatch are a common Dorset tradition

- (a) **Thatch** either simple or ornate. In the case of the "ornate" thatch this usually involves a ridge with a scalloped edge and pattern of sways. Additionally we see examples of bird motifs fashioned in thatch materials.
- (b) **Tiles**. The use of plain clay tiles together with Purbeck stone lacing courses at the roof eaves.
- (c) **Natural Slate**. Natural slate used in conjunction with terracotta ridge or hip tiles.

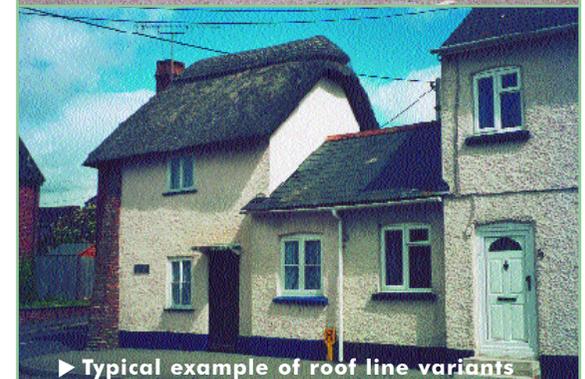
► Typical example of roof line variants

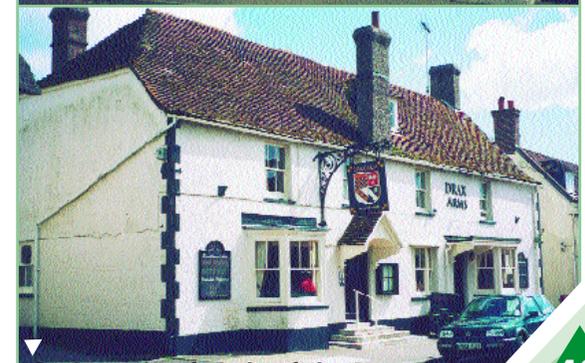
► The imposing facade of the Drax Arms

8.2.4 The Drax Arms, a 19th century public house (including an attached stable to the rear), has roughcast walls over 2 storeys, with smooth plastered quoins beneath a cropped hip tiled roof incorporating tall chimneys. There are double hung sash windows to

the 1st floor and one dormer in the roof, bay windows and main door with gabled tiled wood on brackets.
