BERE REGIS
July 2002
BERE REGIS

CONSERVATION AREA APPRAISAL

BERE REGIS CONSERVATION AREA

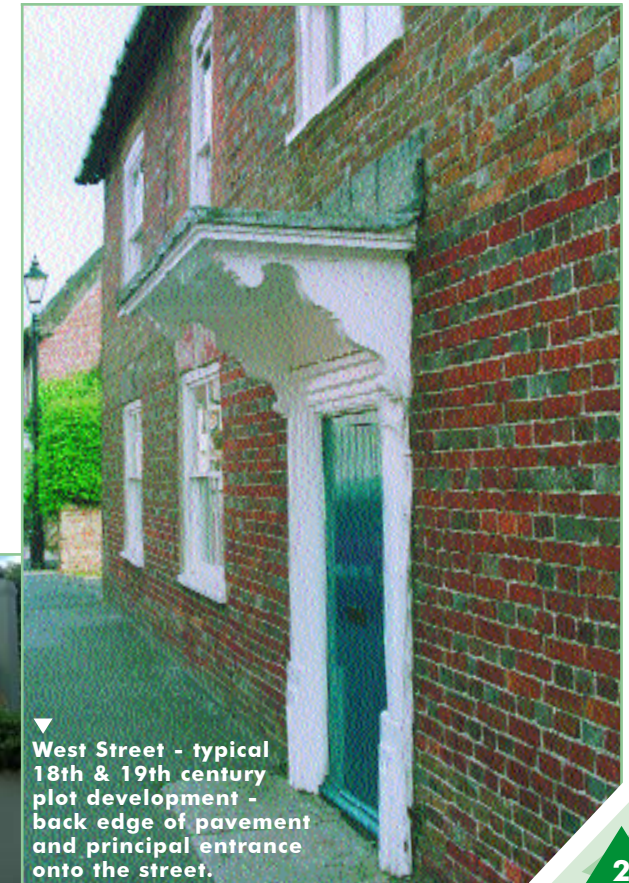
▼ West Street - typical 18th & 19th century plot development - back edge of pavement and principal entrance onto the street.

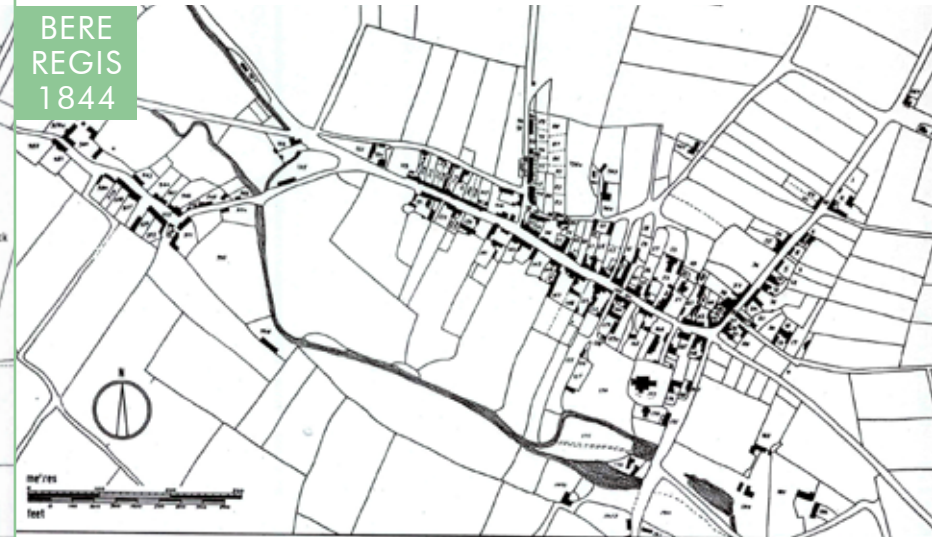
BERE
REGIS
1844

66 BERE REGIS IN 1844 SHOWING TITHE MAP NUMBERS

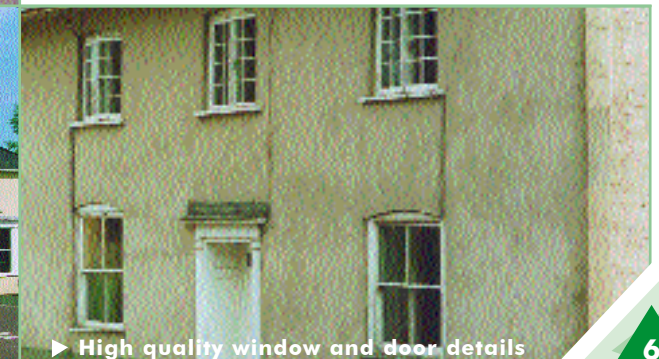
▶ High quality window and door details

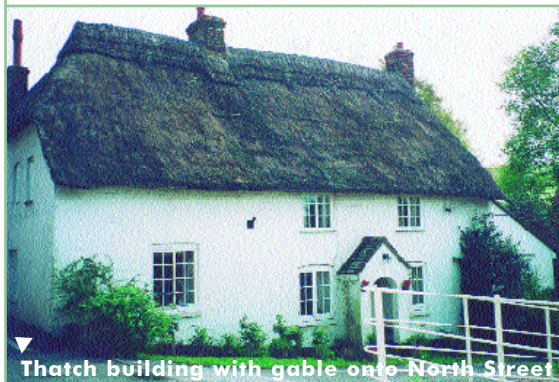
▼ Thatch building with gable onto North Street

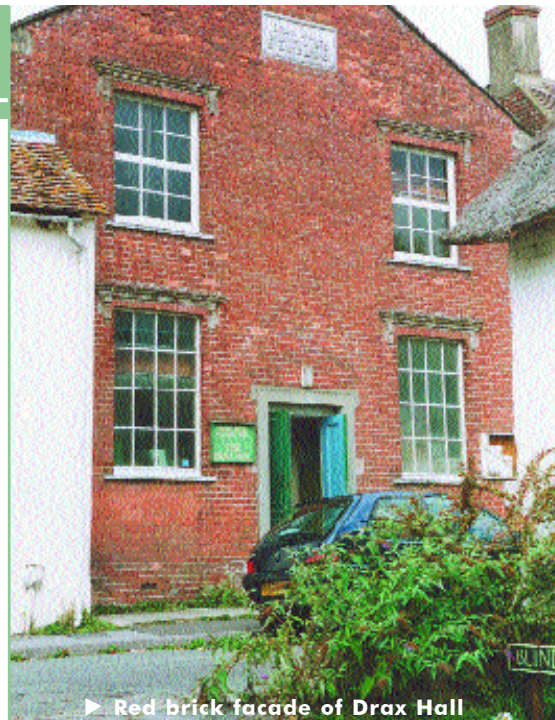
▶ Red brick facade of Drax Hall

- ◆ *The Drax Hall, which existed as a Dissenting Meeting house in the 1777 map and became a Congregational chapel before it was renovated in 1893, displays typical features of this time, including a shallow roof pitch, red brick construction, elegant sash style windows and yellow brick corbelled hood mouldings.*

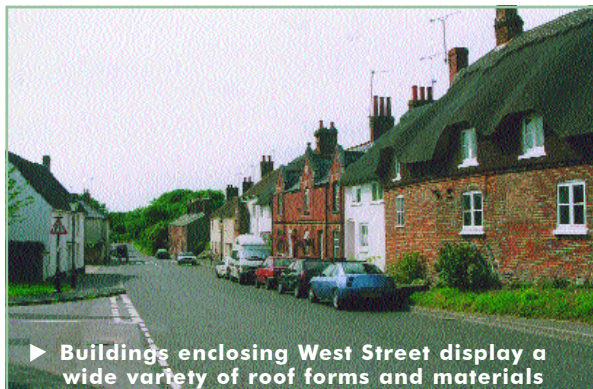
▶ Buildings enclosing West Street display a wide variety of roof forms and materials

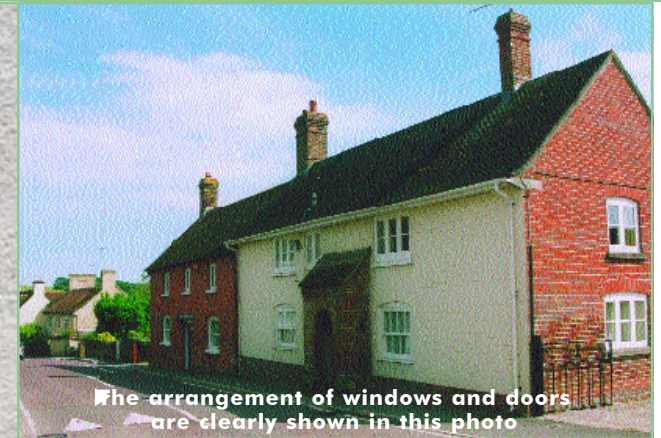
▶ The arrangement of windows and doors are clearly shown in this photo

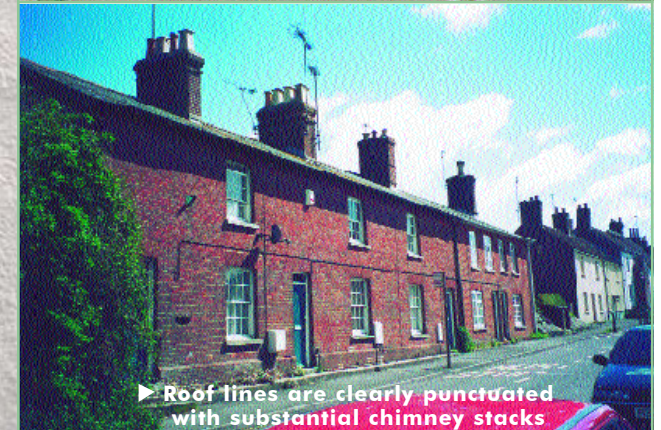
▶ Roof lines are clearly punctuated with substantial chimney stacks

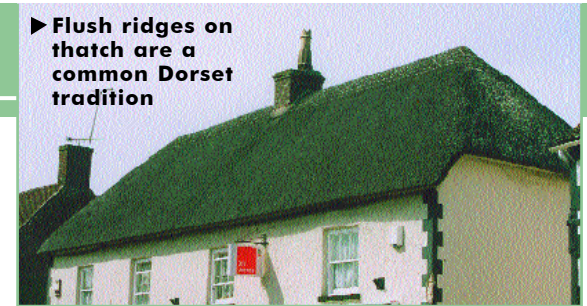
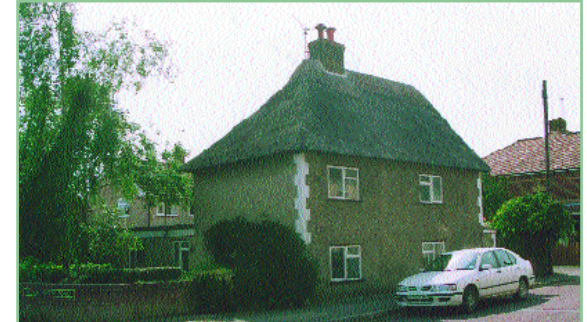
► Flush ridges on thatch are a common Dorset tradition

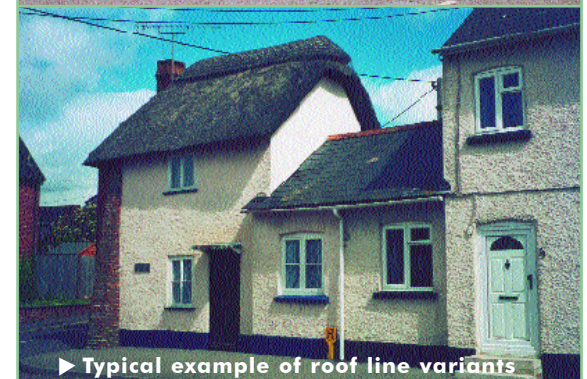
► Typical example of roof line variants

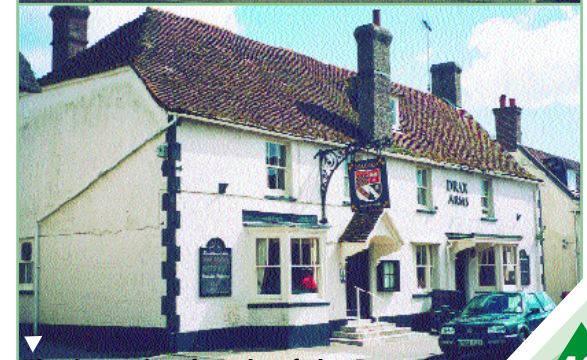
► The imposing facade of the Drax Arms

8.2.4 The Drax Arms, a 19th century public house (including an attached stable to the rear), has roughcast walls over 2 storeys, with smooth plastered quoins beneath a cropped hip tiled roof incorporating tall chimneys. There are double hung sash windows to

the 1st floor and one dormer in the roof, bay windows and main door with gabled tiled wood on brackets.
